TANK WARFARE

ARMORED COMBAT IN THE NORMANDY CAMPAIGN JUNE-AUGUST 1944

Steven J. Zaloga and George Balin

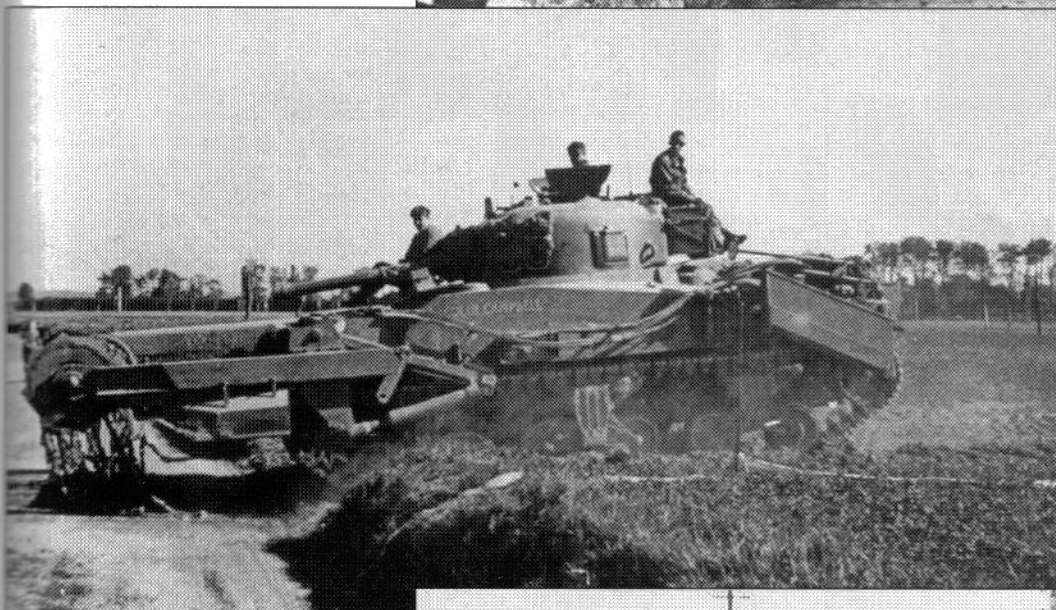
A Sherman Crab named "Colin Campbell" moves forward with the 79th Armoured Div. to help clear minefields. The Crabs were kept very busy in the July fighting due to extensive German minefields near Caen. In this photo, it can be seen that engineers have already marked a cleared lane in the traditional fashion with tape. (The Tank Museum)

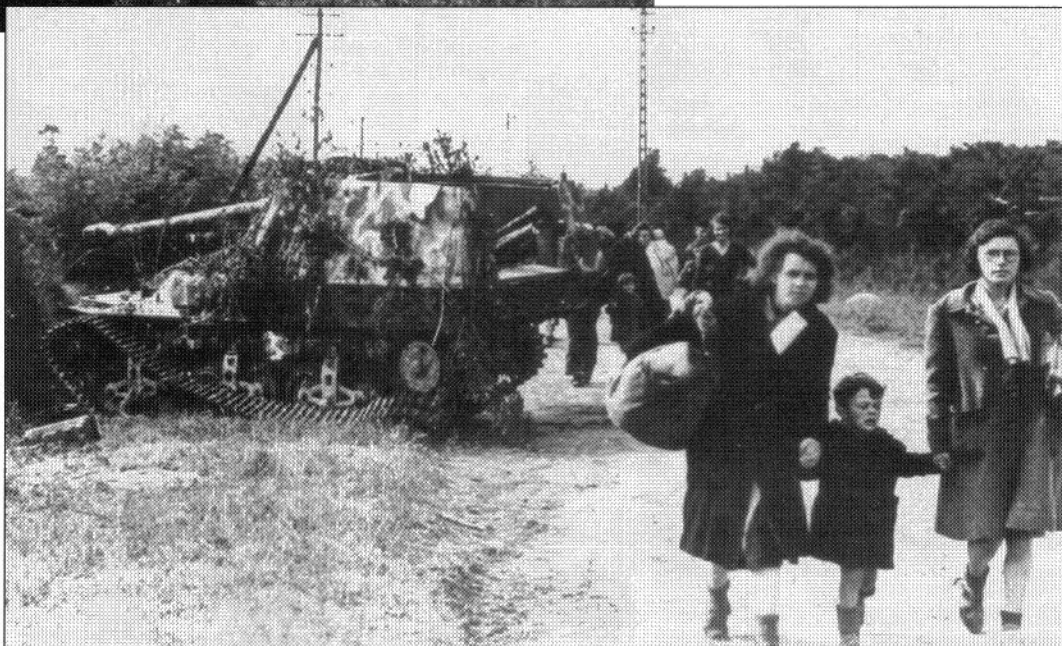
French families flee the fighting in the Norman farm country on 21 June 1944. In the background is a knocked out 7.5cm PaK 40/1 auf Geschutzwagen Lorraine Schlepper (f), another of the myriad Becker conversions so typical of the early Normandy fighting. This was an improvised tank destroyer consisting of the very potent 75mm PaK 40 anti-tank gun on a captured French Chennillette Lorraine armored transporter. Although thinly armored, the conversion gave the weapon more mobility. (US Army)

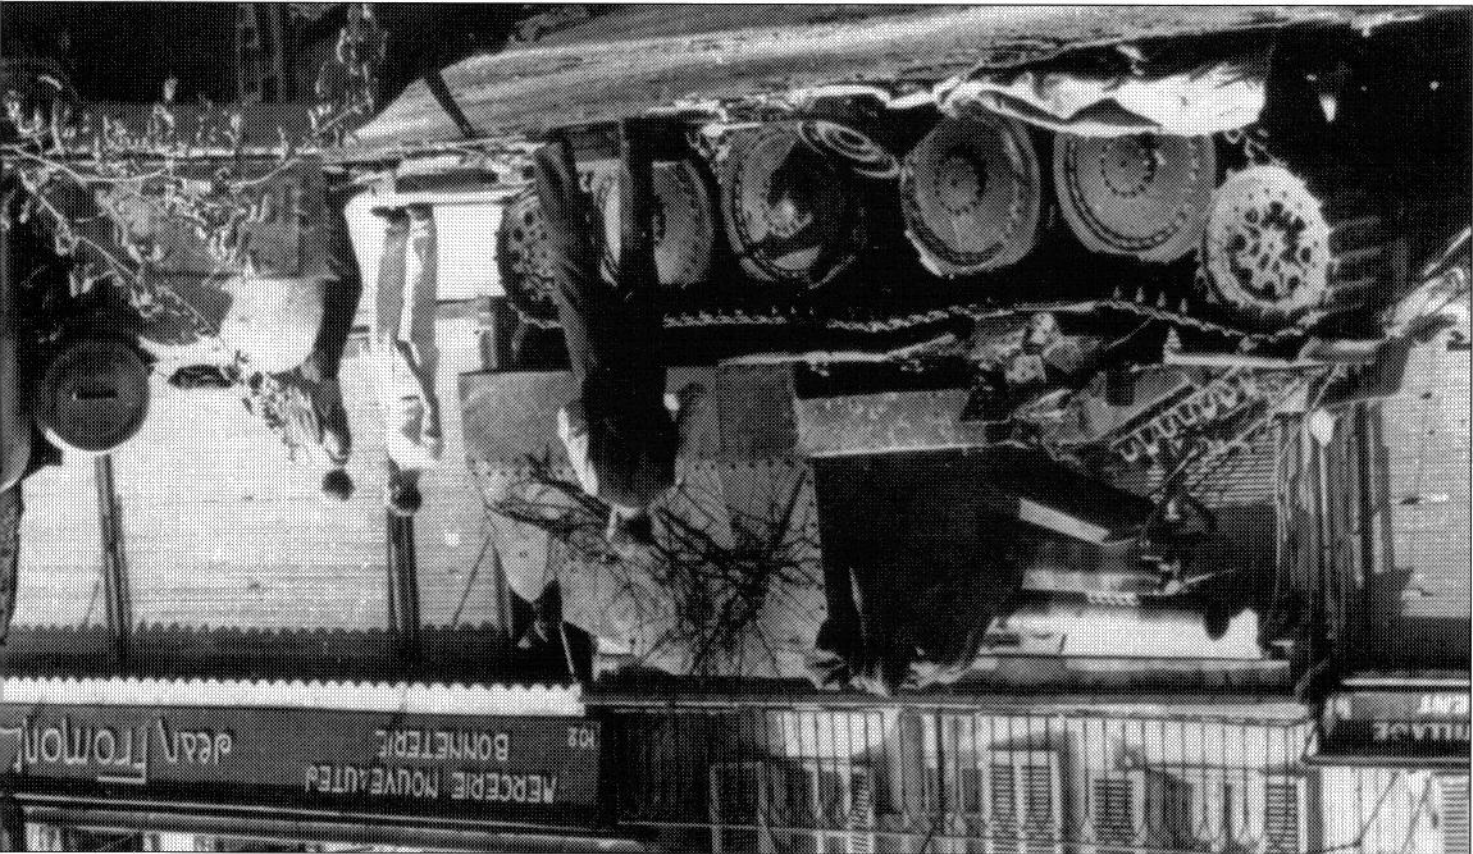
A 15cm Schwere Infanteriegeschütz 33/1 auf Selbstfahrlafette 38(t) lies burned out and abandoned on the streets of a Norman town in July 1994, apparently from a direct tank-gun hit on the side. This self-propelled howitzer was a common weapon in panzer-grenadier companies, and they were commonly called "Grille". A similar tank destroyer version, the Marder III, was built using the 75mm Pak 40 anti-tank gun instead. (US Army)

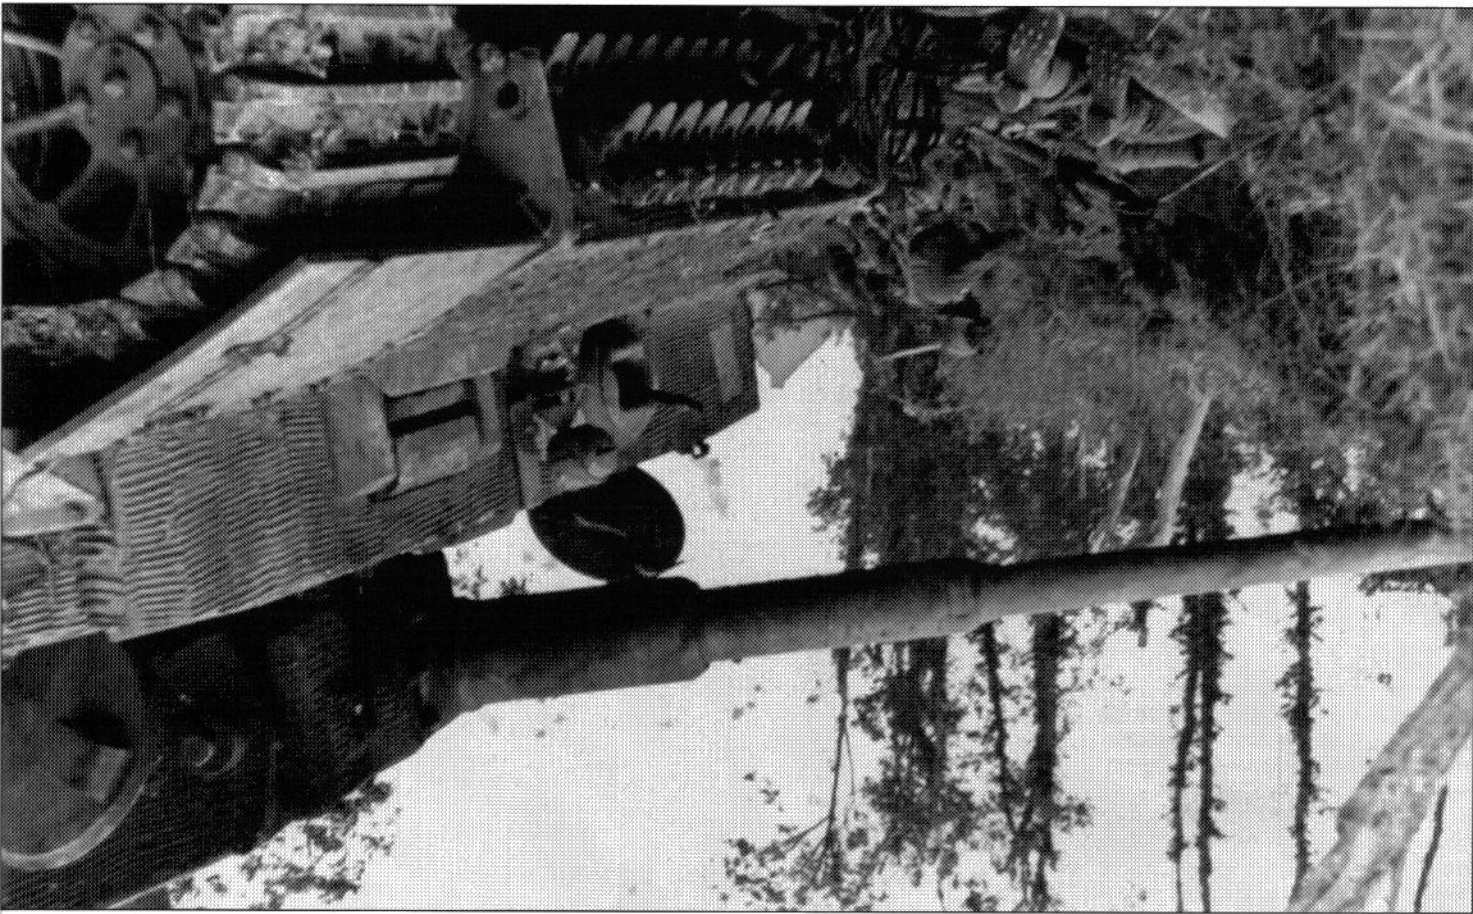
A Tiger I knocked out by British units lies at the base of a gully along the Odon River on 28 June. This appears to be a tank from s.SS-Pz.Abt. 101. Although many of the British anti-tank weapons were ineffective against the Tiger in frontal fighting, the Tiger was vulnerable when attacked from the side by the standard 75mm tank gun. The 1st company of this unit lost 15 of its 45 Tigers in the June fighting, and was pulled back to re-equip on the new Koenigstiger in July, leaving the remaining Tigers in the fray with British forces around Caen. (The Tank Museum)

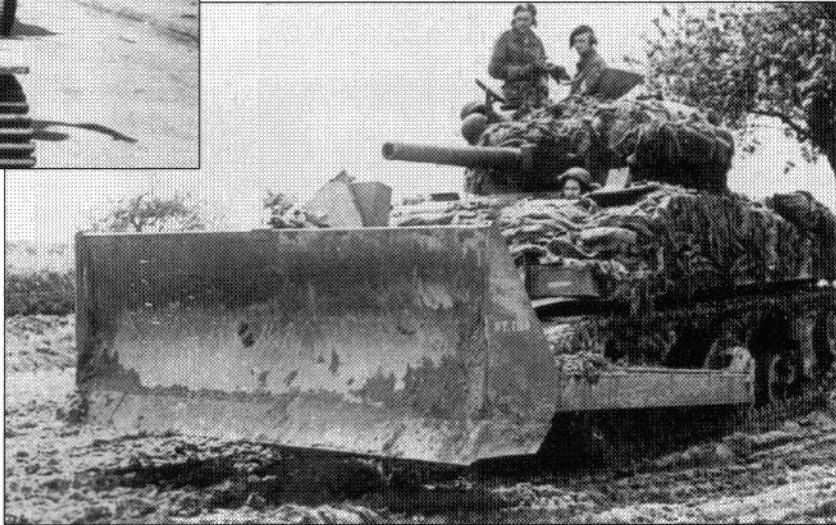
Although a common enough sight in US Army tank units, the Sherman with M1 dozer blade was far less common in British units as seen here. Note the tanker's helmets stowed outside the turret- a necessary substitute for the jaunty British tanker's beret in the Normandy fighting due to the presence of skilled German snipers. This Sherman V is well camouflaged with netting. (The Tank Museum)

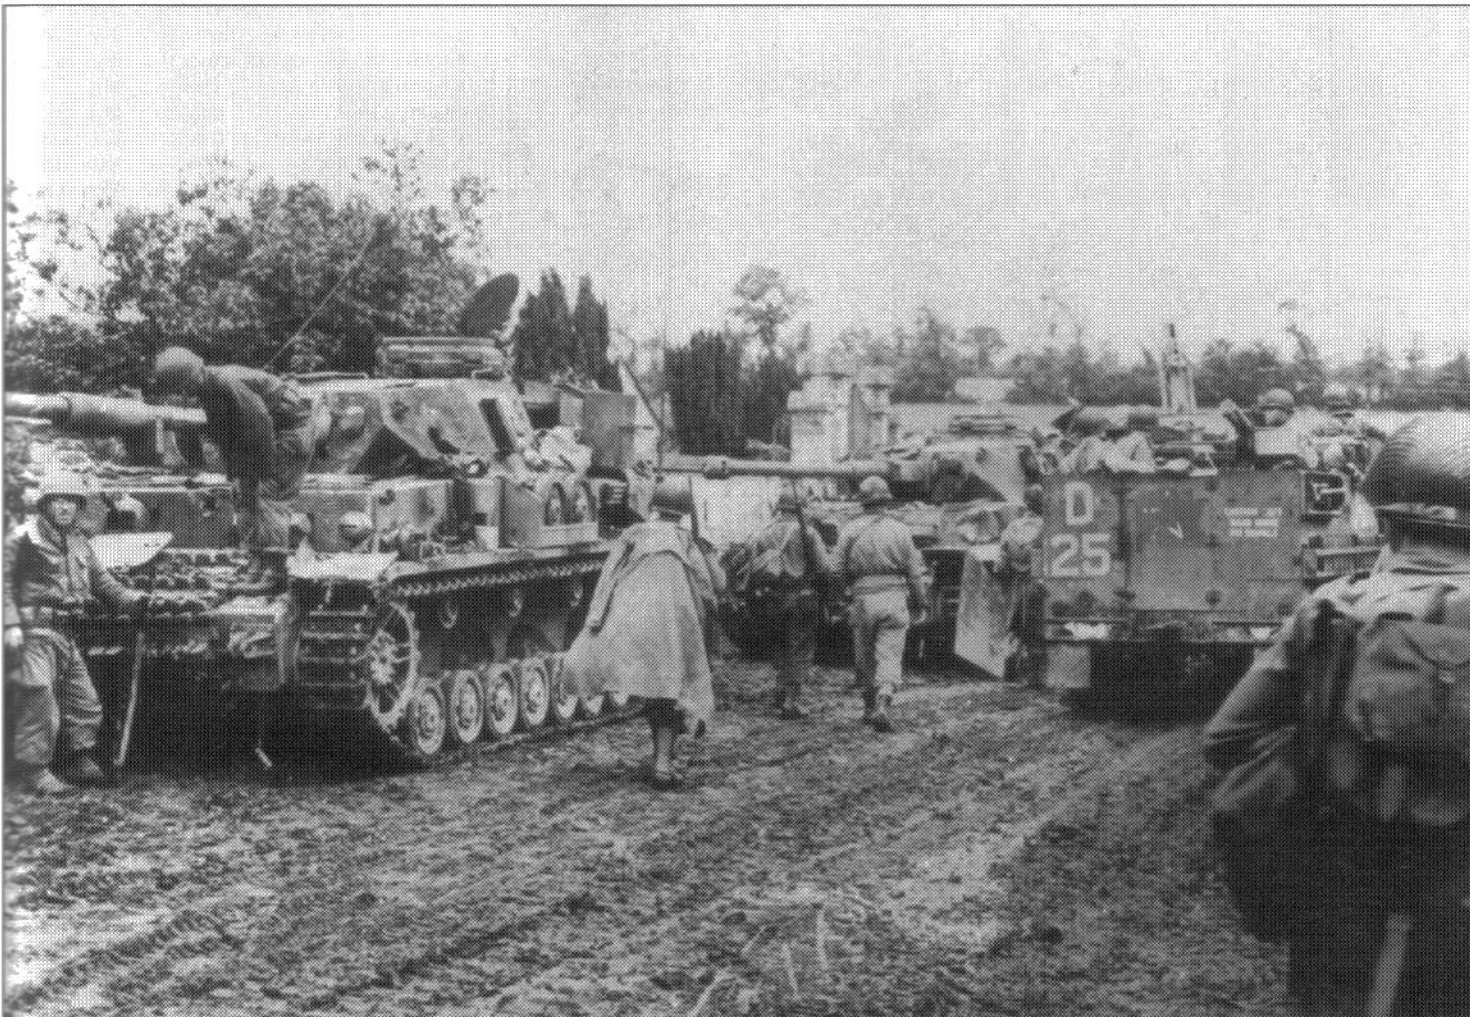
This photo was taken slightly further along the same road as the photo of the M4A1 medium tank near St. Fromond, and shows the knocked out Pz.Kpfw. IV tanks from Das Reich in better detail. Close inspection of the forward tank will reveal a large penetration in the glacis plate, and another on the turret side which led to an internal ammunition fire and explosion which shattered the gun mantlet. To the right of the photo is a M3 half-track personnel carrier from 3rd Armored Div. (US Army)

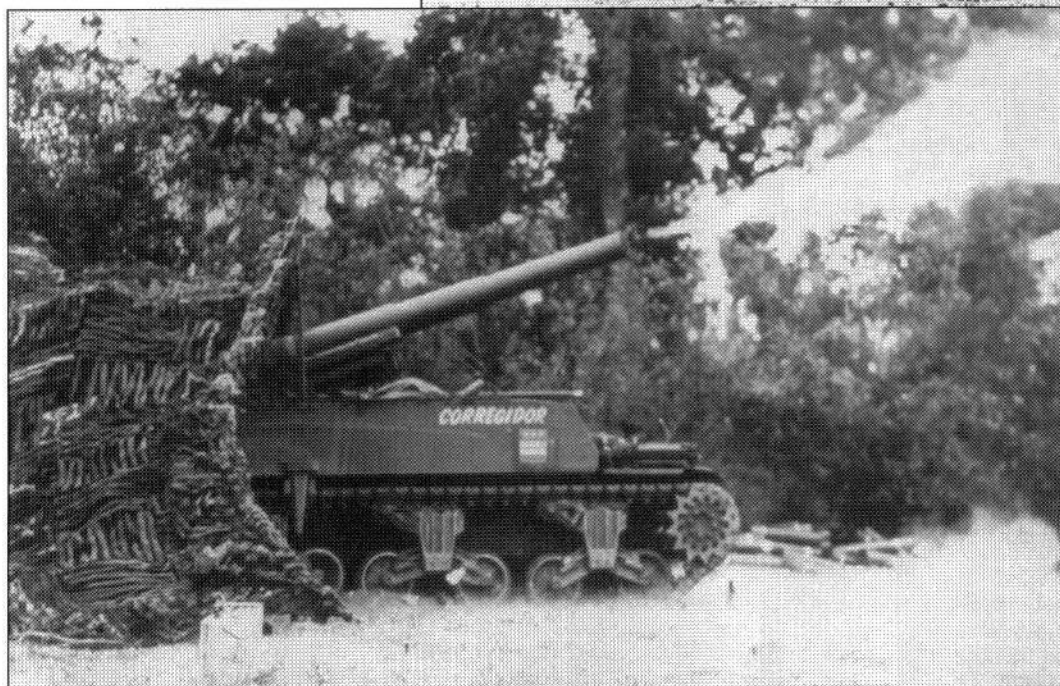
A M12 155mm gun motor carriage named "Corregidor" of the 987th Field Artillery Bn. fires in support of US forces near St. Lo in the Contentin fighting on 16 July. The M12 was a combination of a Sherman chassis with a World War I vintage French 155mm gun. The 987th was the only M12 unit in Normandy until 12 August when it was joined by the 587th and 588th FA Battalions. The M12 was replaced later in the European campaign by the more modern M40 155mm GMC. (The Tank Museum)

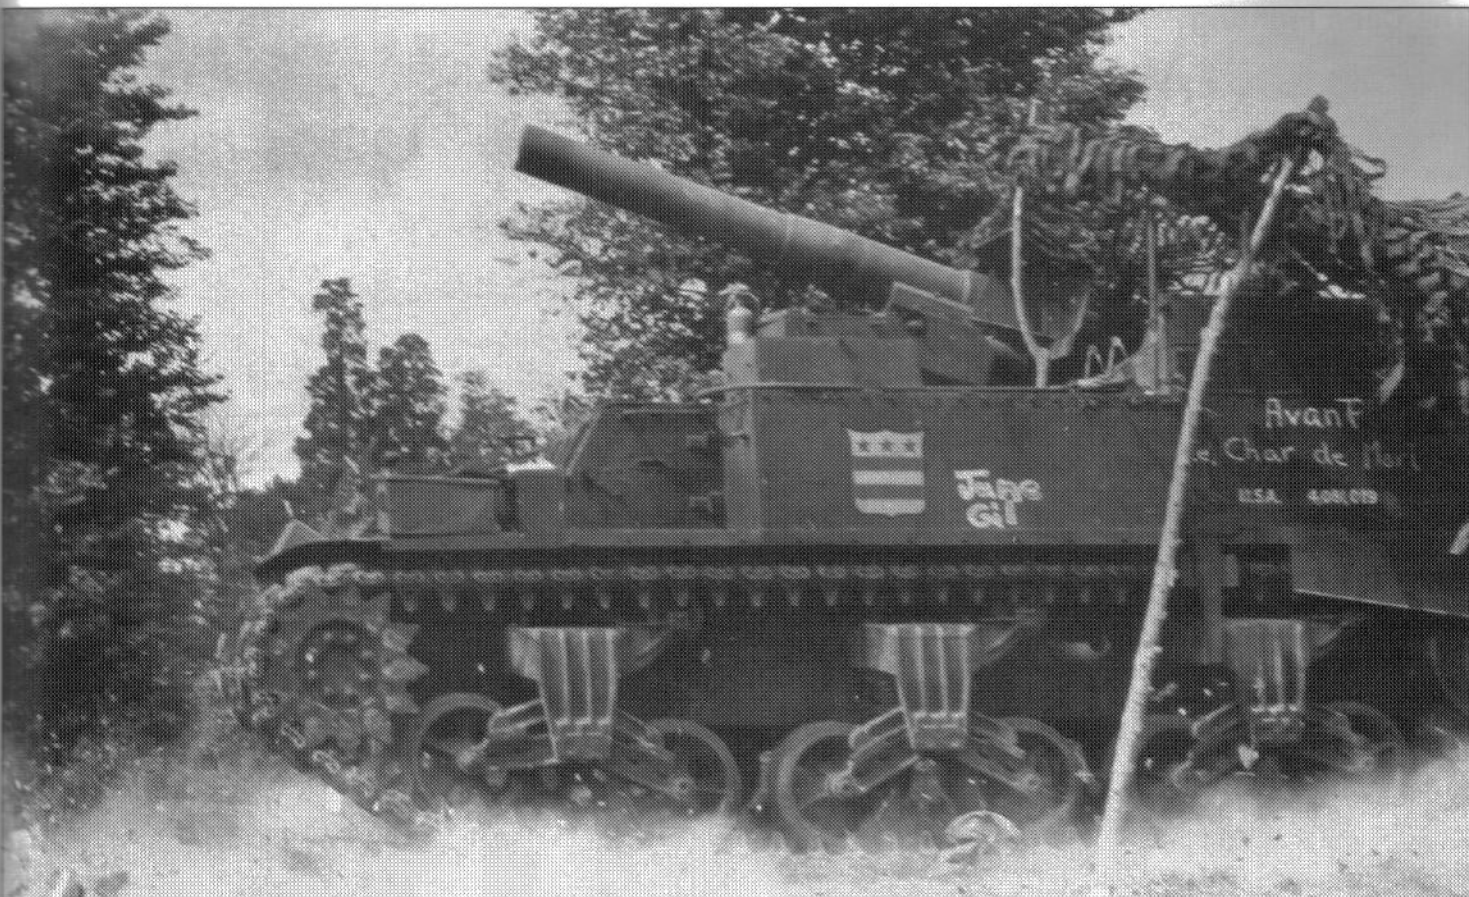
Another M12 of the 987th FA Bn. named "June Gil" in action on 16 July during the St. Lo fighting. It would appear that each battery of the battalion had a slightly different shield design on the hull side. The French inscription on the hull side: "Avant le char de mort!" means "Forward tank of death!".

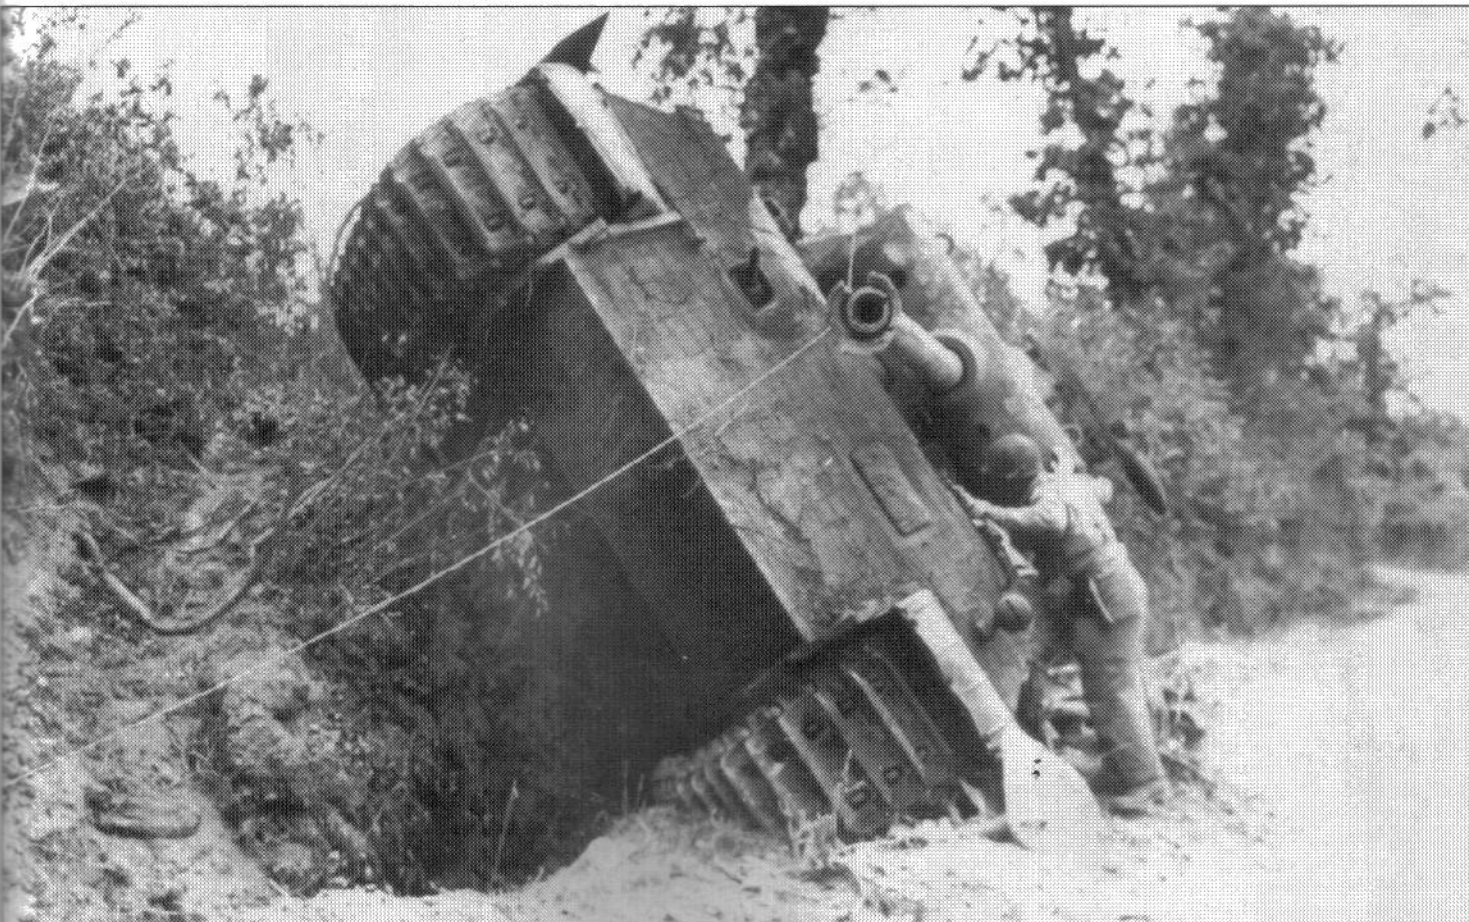
This Panther Ausf. A of 2.SS-Pz. Div. Das Reich was knocked out in fighting with the 22nd Infantry, 4th Infantry Div. during a skirmish near Sainteny on 16 July. The 4th Infantry was one of the two original US infantry divisions to have landed on D-Day, and spent nearly a week of bitter fighting against troops of the 2.SS-Panzer Div. in the hedgerows near Sainteny. (US Army)

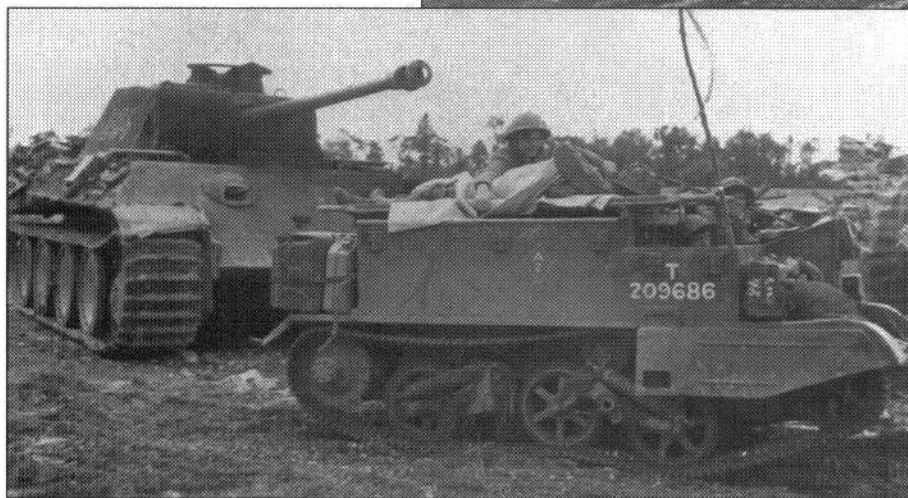
A Universal Carrier being used as an ambulance by the Durham Light Infantry passes by a knocked out Panther Ausf. A near the junction of routes D139 and 173a. This was one of the Panthers of 12.SS-Pz.Div. (Hitlerjugend) which was knocked out by a hit on the left rear side which set its fuel on fire during fighting in late June with the Canadians. (The Tank Museum)

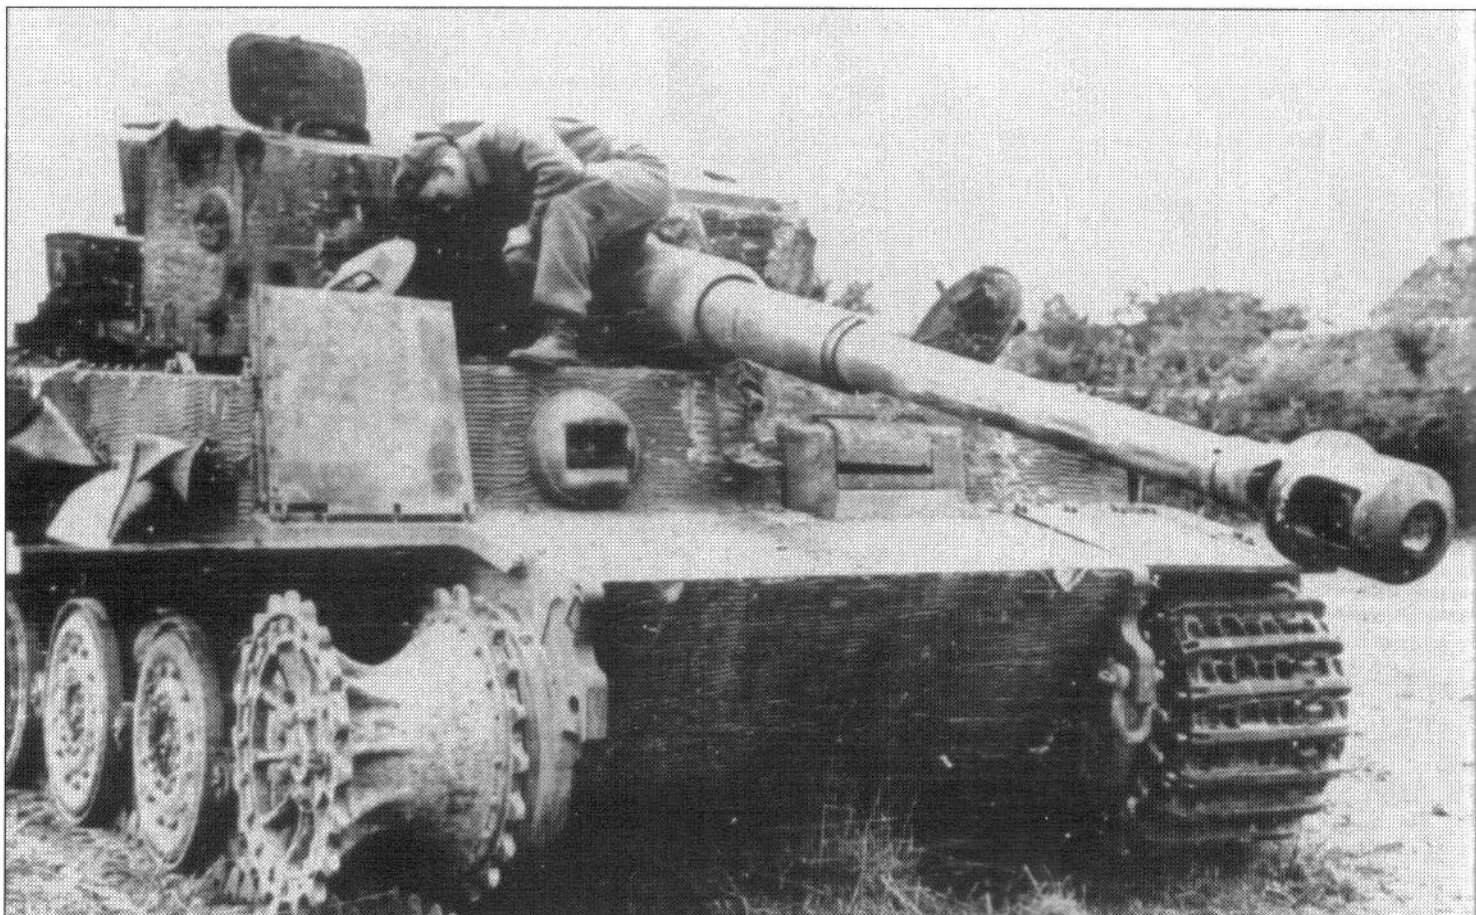
A Tiger I is inspected near Caen by a British soldier. The Tiger was the most deadly nemesis of British armor in the Caen fighting, and both German heavy tank battalions operated in the British and Canadian sectors, most memorably around Hill 112. This is a late production type with steel-rimmed road wheels, and has obviously suffered an internal ammunition explosion. (The Tank Museum)

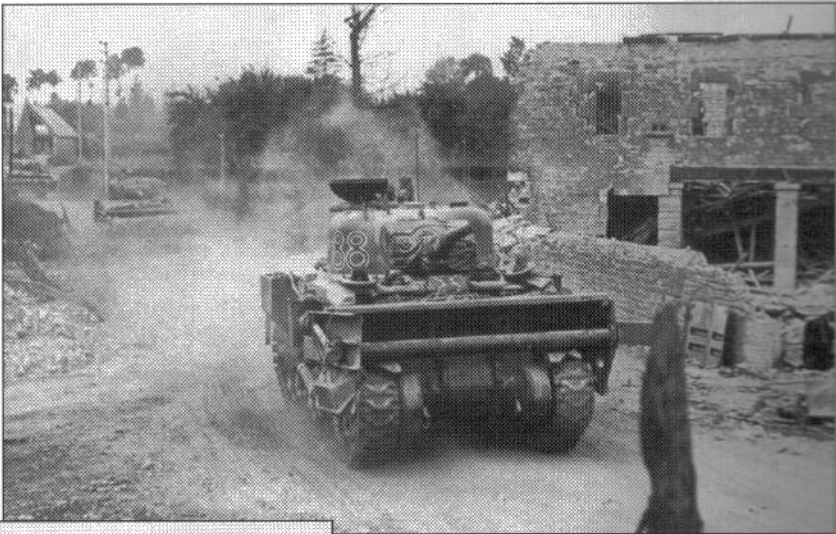
A Sherman Crab of the 79th Armoured Div. in action near Tilly-sur-Seulles on 11 July. The lead tank has obviously been damaged during mine-sweeping operations and its flag is absent; the following tanks appear intact. (The Tank Museum)

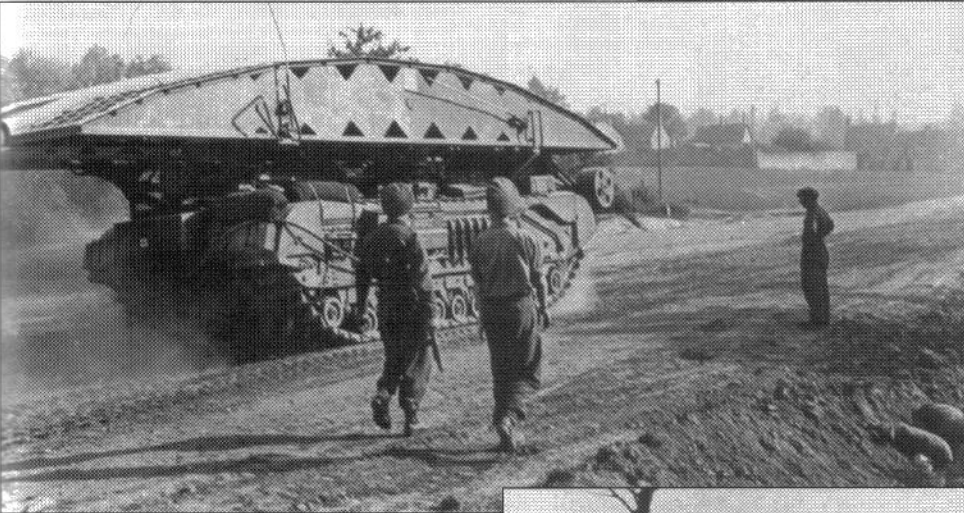
Instead of the improvised SBG bridges used by the 79th Armoured Division on D-Day, the Churchill tank brigades in Normandy were provided with the more refined Churchill Bridgelayers seen here. These were issued on a scale of one troop of three bridgelayers per brigade HQ. They were used in the Caen fighting mostly to gap obstacles and tank traps. (The Tank Museum)

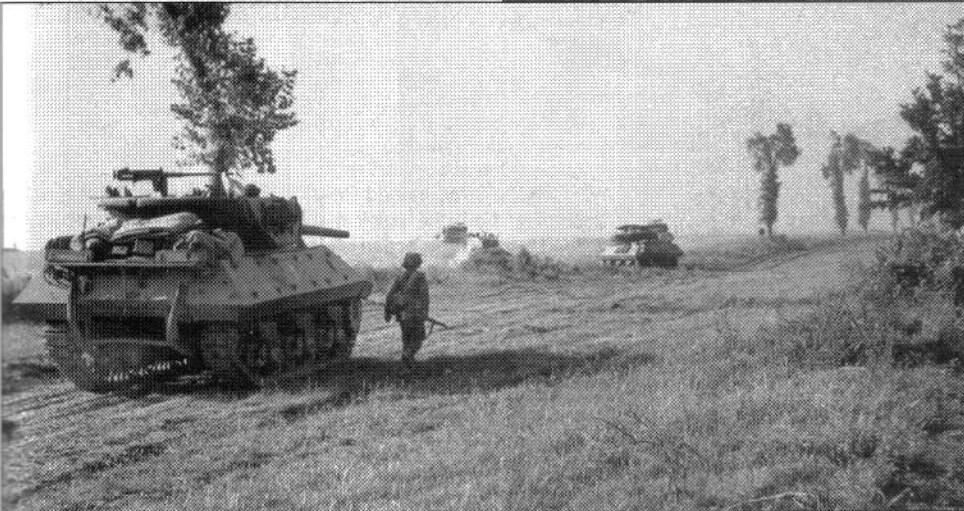
A British M10 Achilles Mk. 2 moves forward between Troarn and Caen during the July fighting. In British service, the M10 was deployed in anti-tank regiments which consisted of four batteries, with 24 M10s in two batteries, and towed 17 pdr. anti-tank guns in the other two. This differed from the American practice of deploying tank destroyer battalions equipped entirely with towed or self-propelled guns. (The Tank Museum)

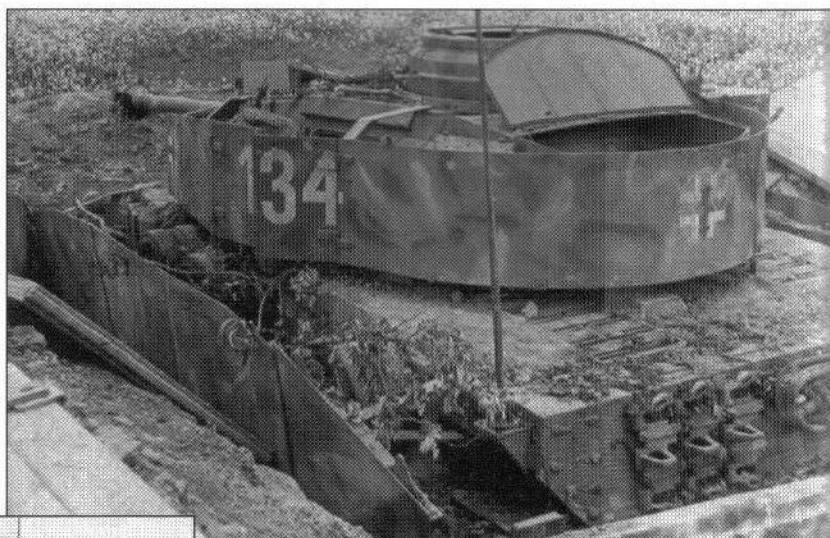
A Pz.Kpfw. IV Ausf. H of Pz.Rgt. 22 (21.Pz.Div.) knocked out near Lebissey on the northeast approaches to Caen. This photo was taken on 13 July after the British 3rd Division had captured the area. This tank has been well dug in with only its turret showing, a common tactic in the Caen fighting. This view provides a good view of the tank's camouflage painting as well as its tactical numbering. (The Tank Museum)

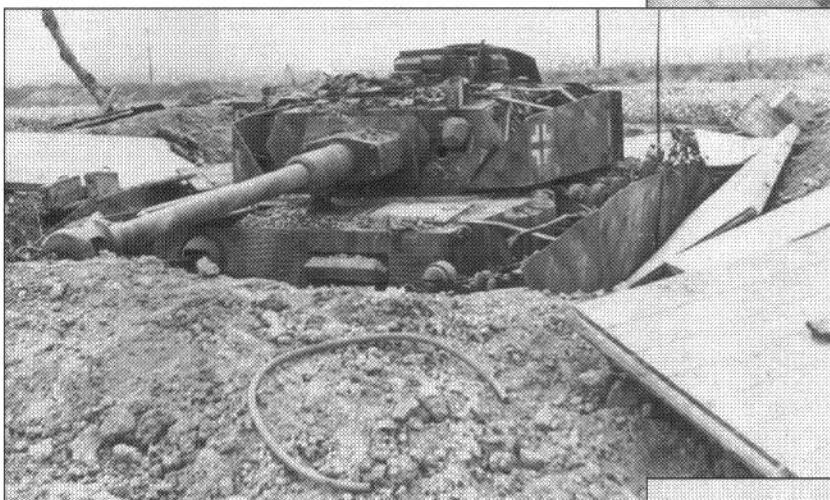
This front view of the Pz.Rgt. 22 Pz.Kpfw. IV shows the cause of its demise, a solid penetration of the turret front to the left of the gun mantlet. Dug-in tanks like this provided a real problem to the Allies, as they were very hard to detect and to knock out. The belfry of the Abaye aux Dames can be seen in the background. The flat terrain in the approaches to Caen allowed the Germans to employ their superior long-range tank firepower to bloody effect against the oncoming British and Canadian armor. (The Tank Museum)

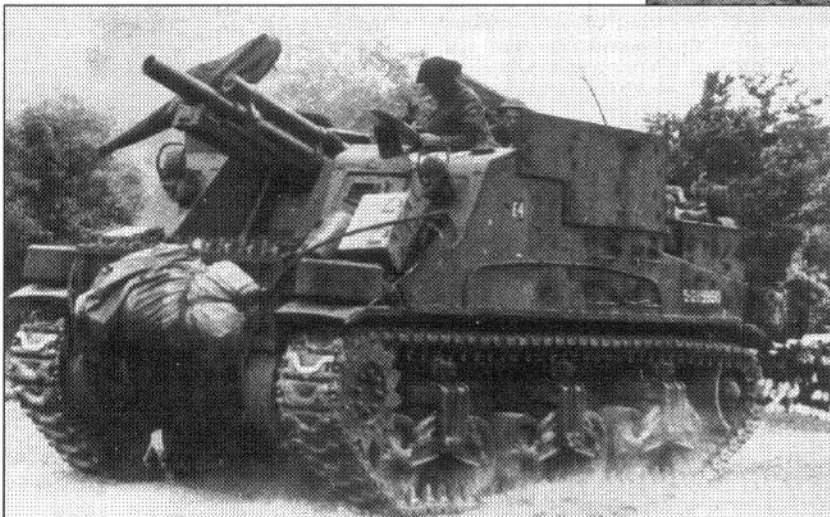
The M7 was named Priest in British service, the nickname stemming from the pulpit machine gun mounting on the right side. This Priest in action near Caen during the 18 July artillery preparation for Goodwood is still fitted with the side panels for deep wading; they were probably retained to provide some modest anti-sniper protection. The standard Royal Artillery tactical marking on the superstructure side, a blue square with a smaller red square in the lower left corner, indicates a howitzer of 3 Battery, the white E4 indicates the 4th howitzer of E Troop. The Priest was gradually replaced by the Sexton in the British army in order to standardize, and some Priests were "defrocked" later in the Normandy campaign to serve as infantry transporters. (The Tank Museum)

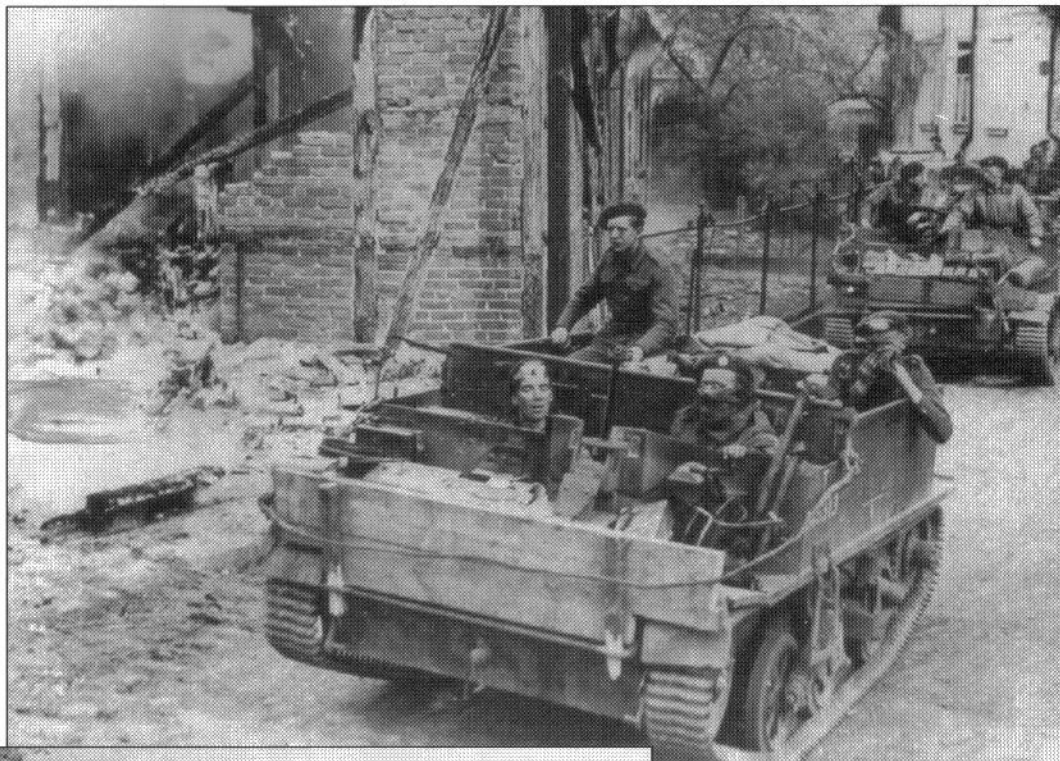
A Universal Carrier column moves forward in a damaged Norman village in July. The carrier was the only fully-tracked infantry vehicle commonly used during the war; both the US Army and German Wehrmacht used half-tracks. This vehicle is being used as a machine gun squad carrier, evident from the tripod stored in front. Notice also that a Boys anti-tank rifle is still being carried in the forward compartment, though most certainly not for tank hunting! The crew has placed some wooden planks on the hull front to create an improvised storage area for their equipment. (The Tank Museum)

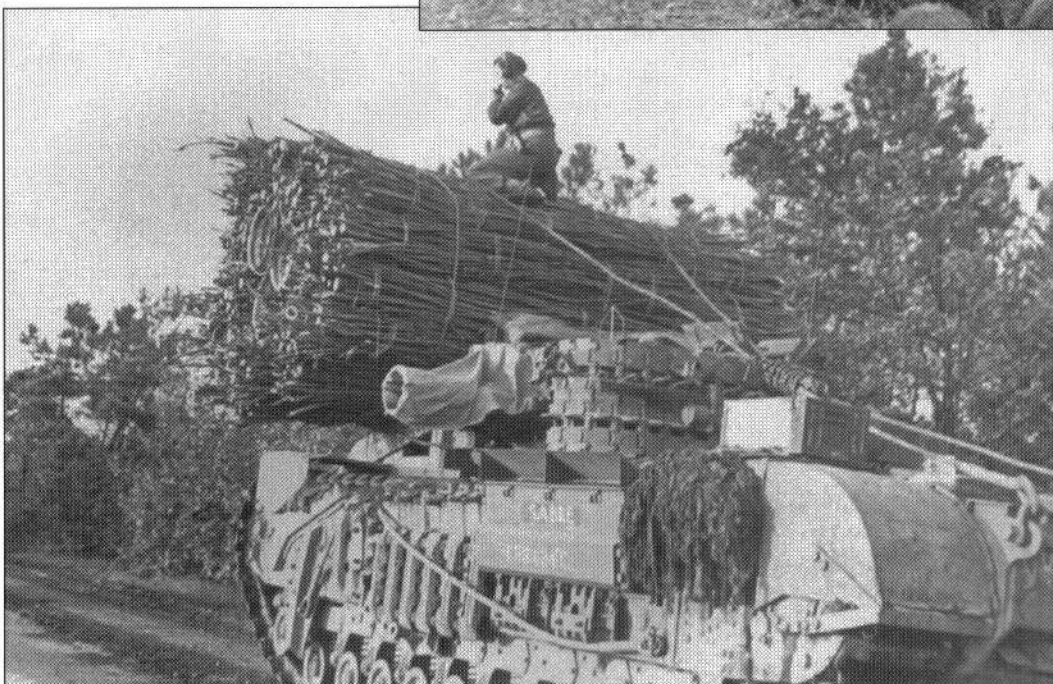
The Churchill AVREs continued to serve throughout the campaign in a variety of functions. This tank, named "Sabre", is being used to carry a fascine for filling anti-tank ditches. Note the Panther track wrapped around the turret front, an attempt to bolster the front protection. (The Tank Museum)

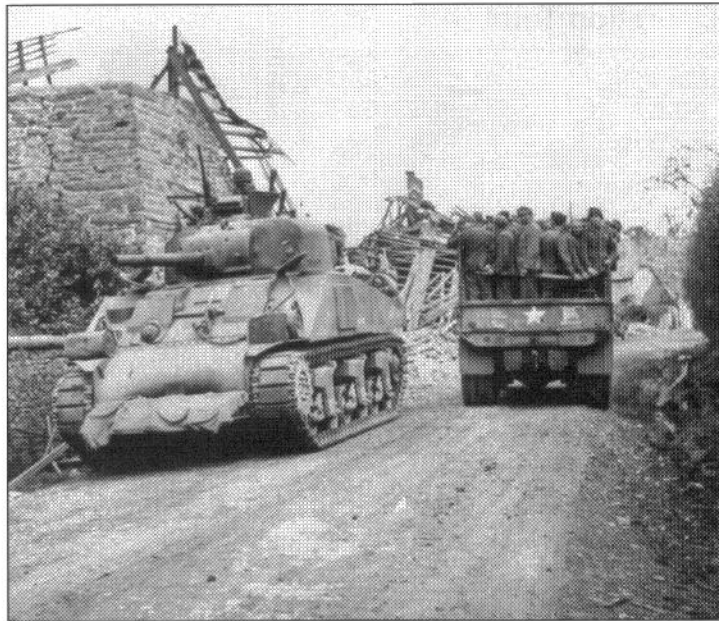
In July, a US Army sergeant named Curtis Culin devised a simple expedient to help break through the hedgerows. A "salad fork" or steel girders was welded together and attached to the transmission housing. When a tank charged the hedgerow with this device on front, it would rip into the roots and punch through them rather than the tank crashing over the top and exposing its thin belly armor to German anti-tank guns. These were called "Culin devices", "prongs" or "Rhinos". When first attached in late July, as seen here, they were still secret and so were covered with canvas. (The Tank Museum)

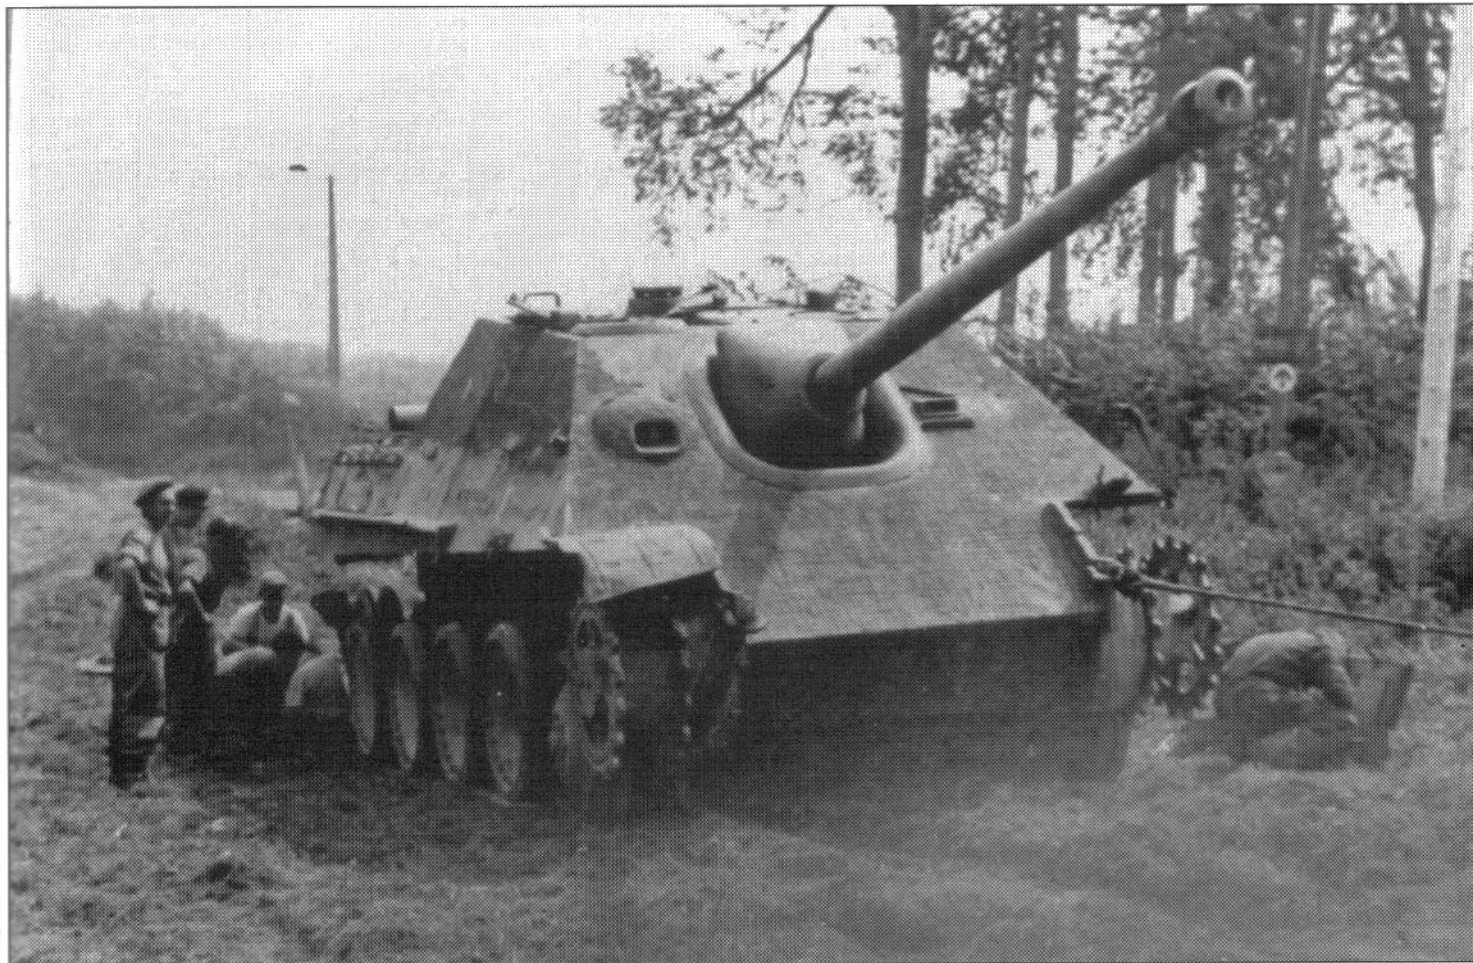
As if the Panther was not deadly enough, the Jagdpanther combined a Panther chassis with an 88mm anti-tank gun. Only a single battalion of these served in Normandy, in the British sector. On 30 July, a squadron of 6th Guards Tank Brigade was ambushed by three Jagdpanthers of s.Pz.Jg. Abt. 654 near les Loges, and about ten Churchills were knocked out in quick succession. The other squadrons brought the three Jagdpanthers under fire, and two were later found abandoned with serious track damage, including the one seen here. (The Tank Museum)

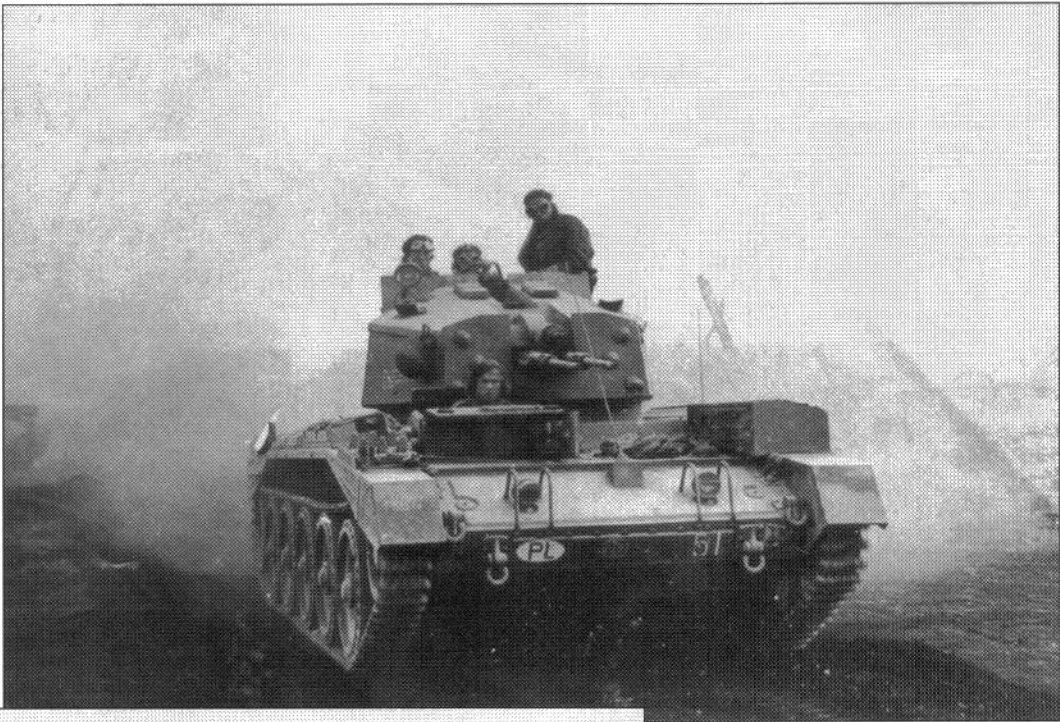
Another view of a Polish Crusader AA tank in the staging areas south of Caen. This view clearly shows the new turret fitted to this variant. The vehicle commander is using the articulated sight that was linked in elevation with the guns. (Pilsudski Institute)

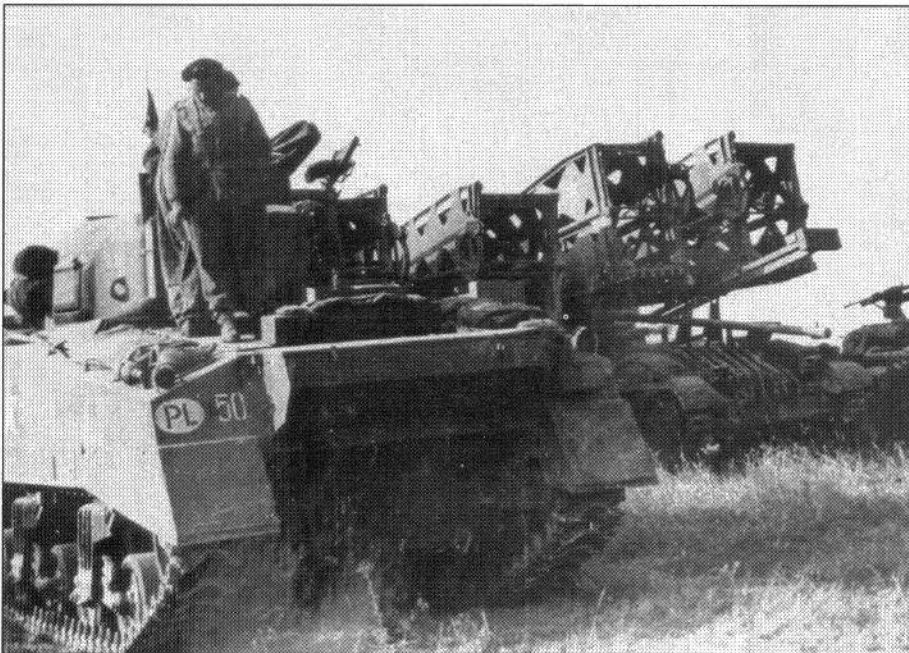
The Polish 1st Armoured Division used some of the less common types of specialized equipment in Normandy, like this Valentine bridgelayer seen behind a Sherman V of 10th Armoured Brigade headquarter troop. The Poles used the European automobile oval insignia for national identification; next to it is a white 50 on a red square which indicates the 10th Armoured Brigade HQ. (Sikorski Institute)

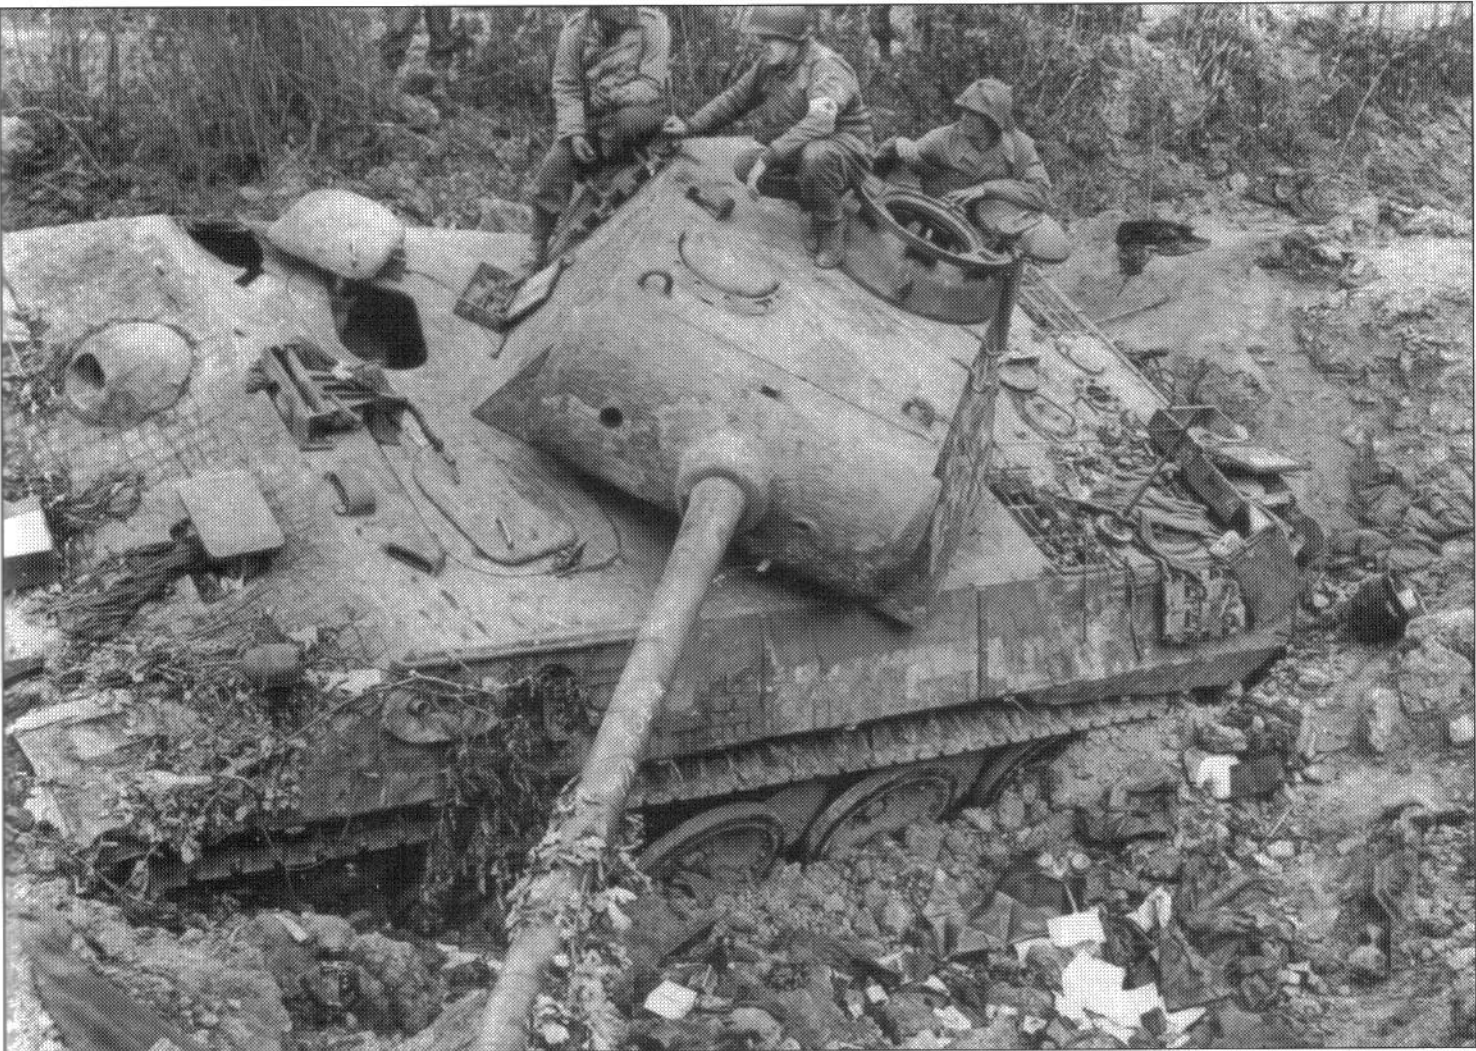
On 25 July, the US Army First Army began a major breakout operation south from St. Lo, called Operation Cobra. The attack was preceded by a heavy bombardment which wrecked the opposing Panzer Lehr Division. This Panther Ausf. A was a victim of the preparatory bombardment: note the shattered armor on the right front corner of the hull, probably caused by a bomb or aircraft rocket. (US Army)
